PALMDALE DRIVE

Facts, Issues & Warnings

A Pictorial Review

Concerned Residents of El Dorado Hills Heritage Village
nonprofit public benefit corporation

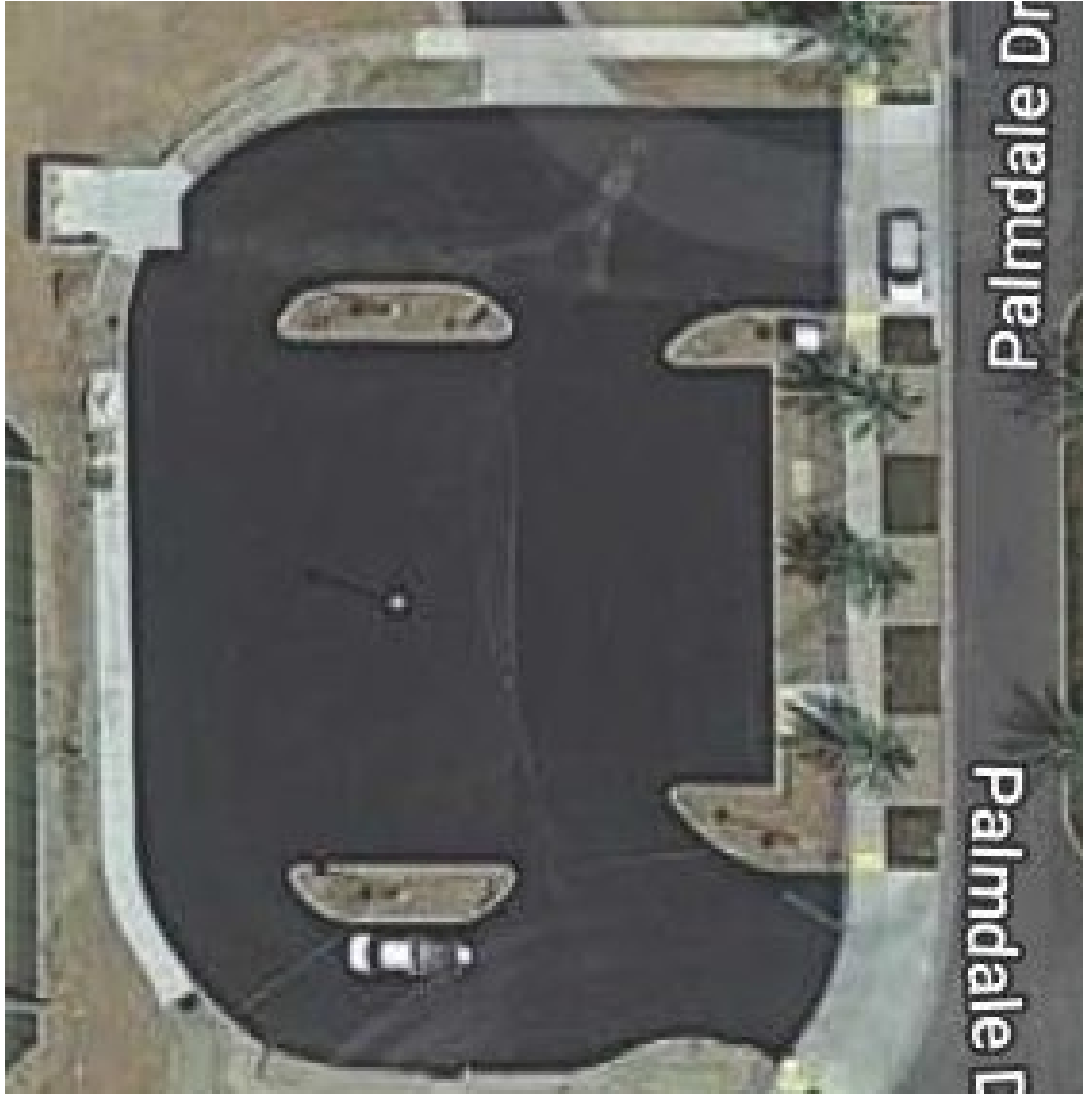
Parking Lot - 23 Spaces, No Legal Street Parking

Some spaces are restricted for handicap and service vehicle parking. Available spaces for use by general public approximately 18. Totally inadequate parking for a park promoted for remote player competitive leagues.

Striping for traffic flow must be provided

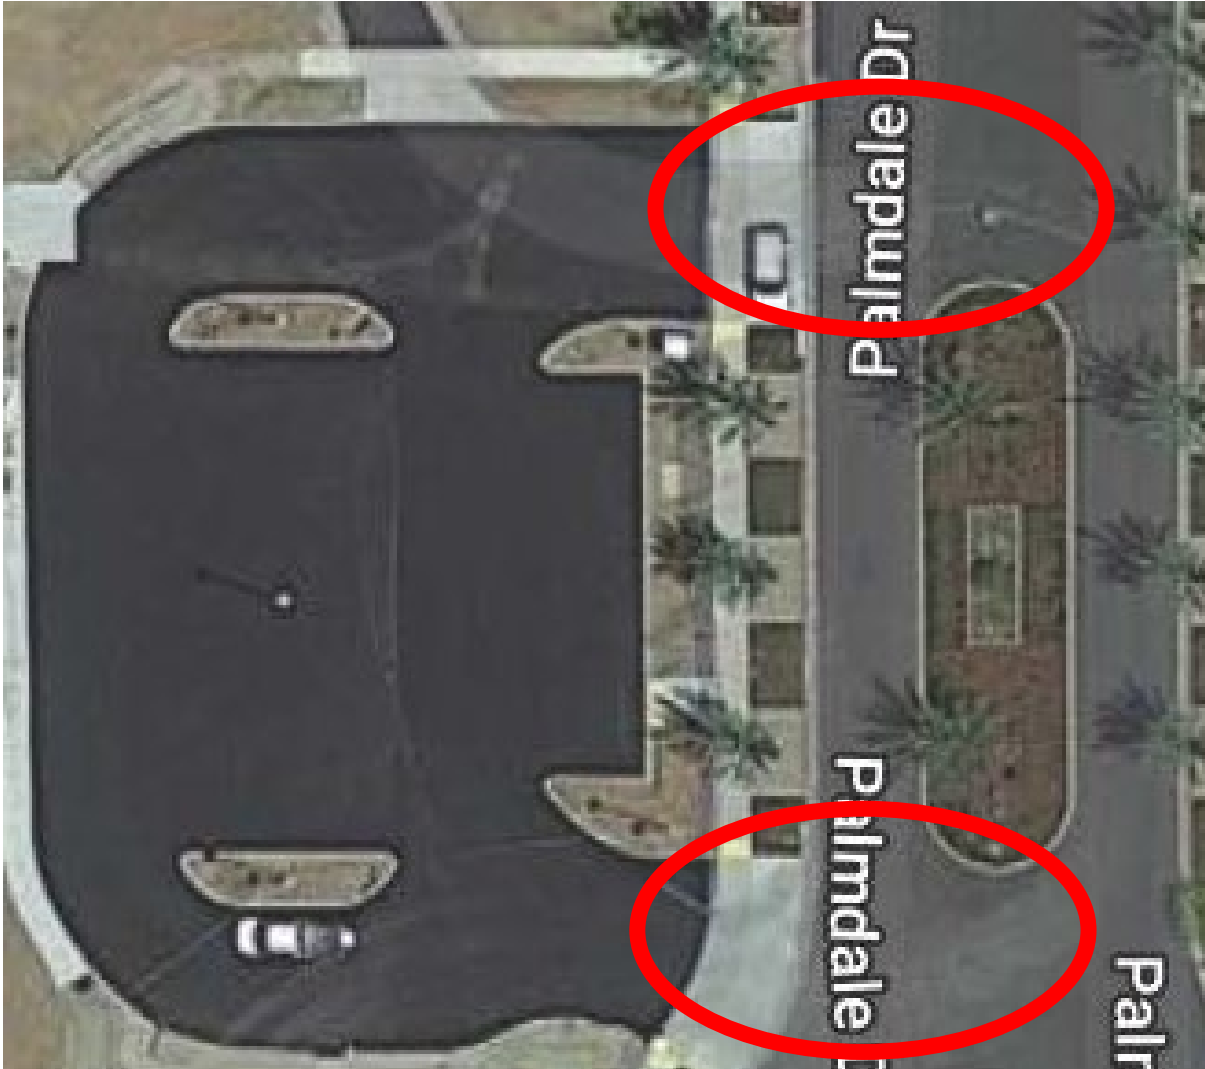
Two Exits to Palmdale, Across Blind Islands

In addition to traffic from park exits, vehicle, bike, and pedestrian flows will occur from Carson Crossing, multi-use trail, and residential / commercial entrances and exits.

Blind spots exist from the Carson Crossing monument sign, to/from trails, divider vegetation, and Heritage gates

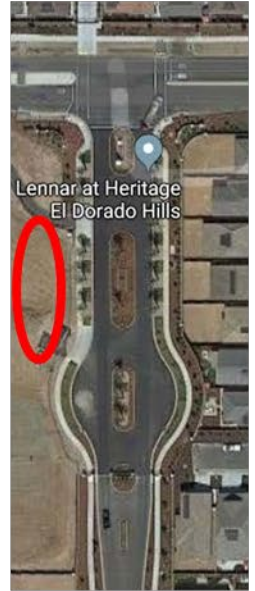
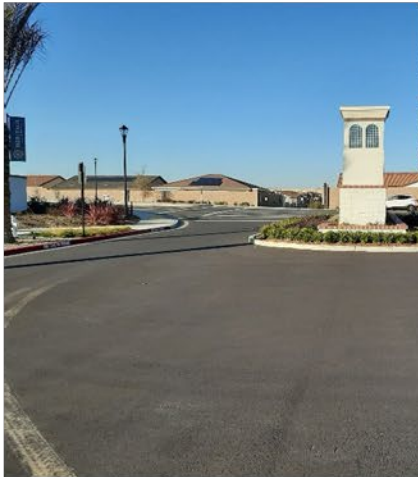
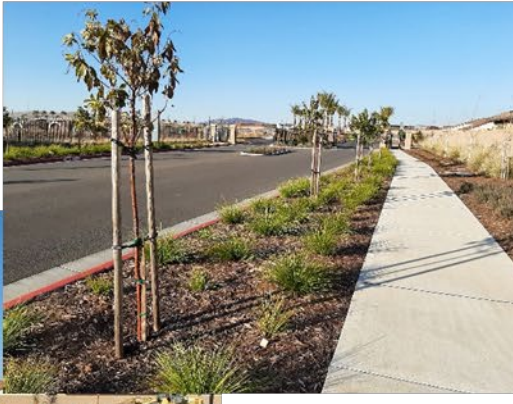
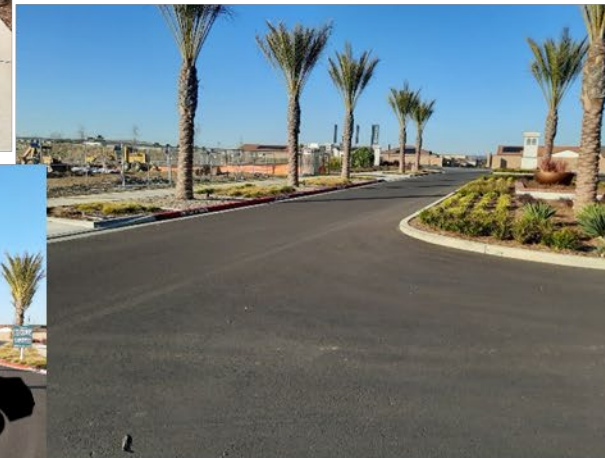
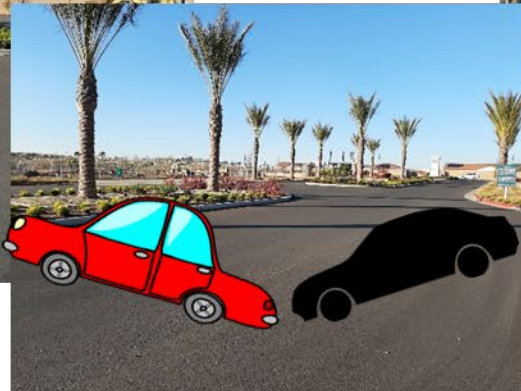
SAFETY CONCERN: PARK PARKING LOT EXIT

- Exit Requires Navigating Traffic – Left, Across Island & Left
- Blind Spot of Over 100 Feet to Right at Gate
- Drivers Must Beware Persons Walking, Biking, Using Scooter, etc.
- Concern Whether Park Visitors Will Use Appropriate Caution
- Accidents Happen But Can Be Mitigated
- Consider: Eliminate Parking Lot for Safety and Environment, Change Exit Location

Cross Vehicle Island

Vehicles Coming from Right

Left Blind Spot at Gate

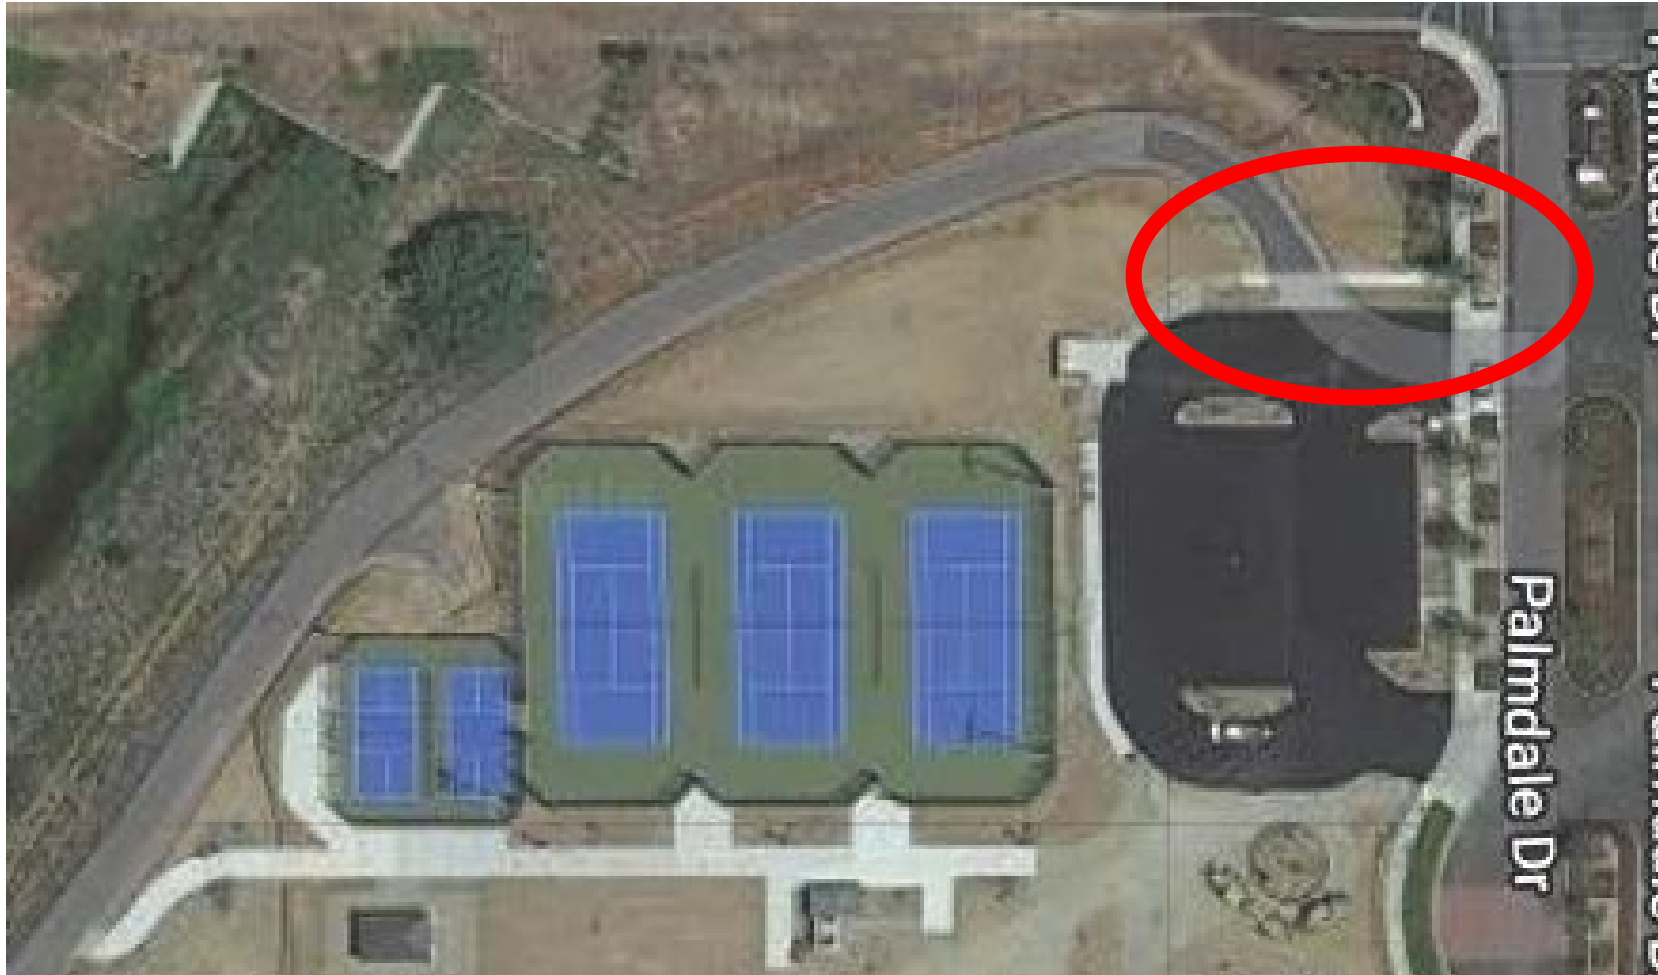
Biking Trail Exit to Palmdale & Parking Lot

Rapid incline from the multi-use trail does not provide clear traffic visibility to Palmdale or the parking lot.

View of street is obscured from trail and vice versa for vehicles entering park.

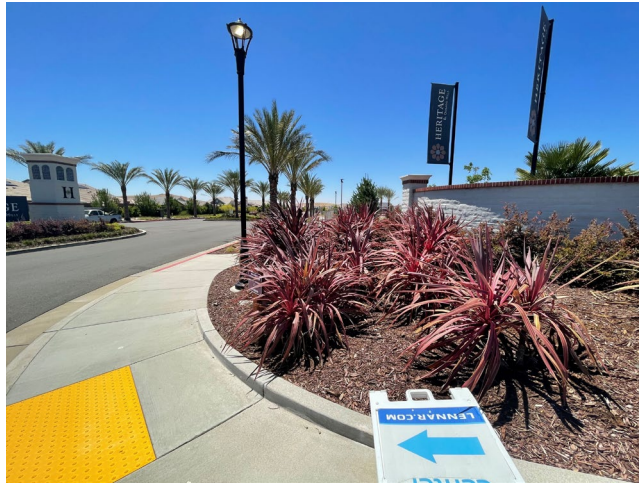
Hazardous Trail Termination at Park Entrance

View from right turn lane
westbound Carson Crossing
vegetation and monument obscure

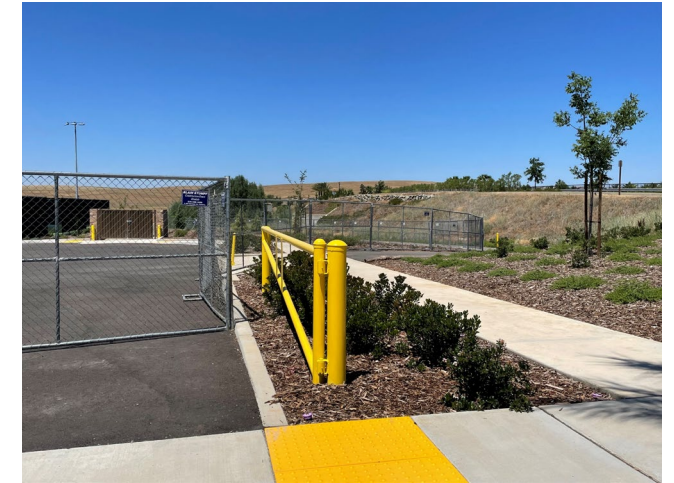
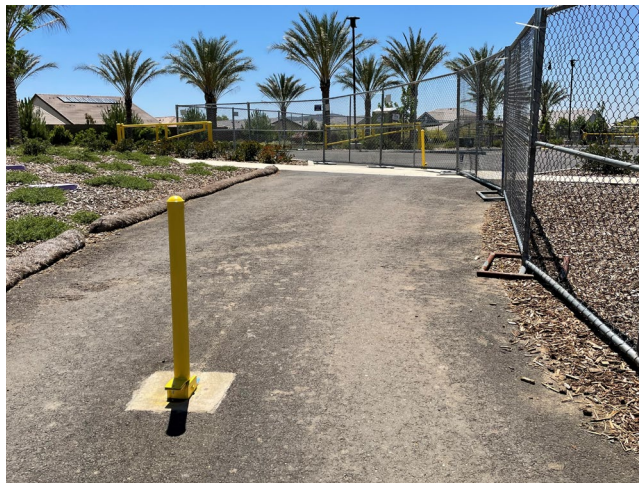
Trail termination at sidewalk and
Park lot has no directions or
cautionary signage

Approach to Park termination from
trail raises and curves with hill to left
obscuring street and has no signage
of trail termination or directions

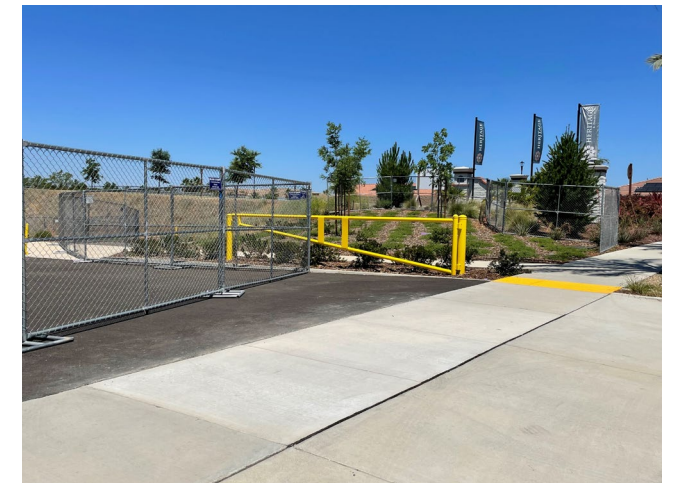
Another view of trail termination at
park showing bicycle/pedestrian
separation with lack of signage

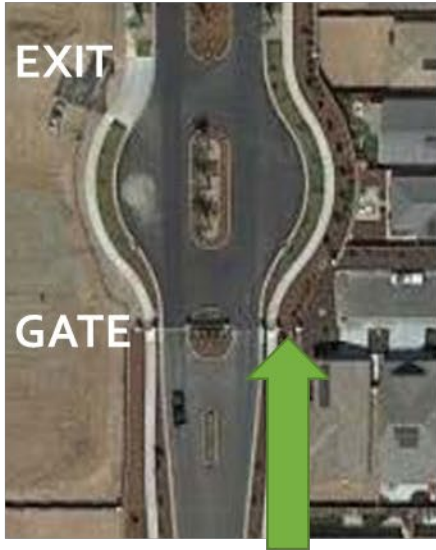
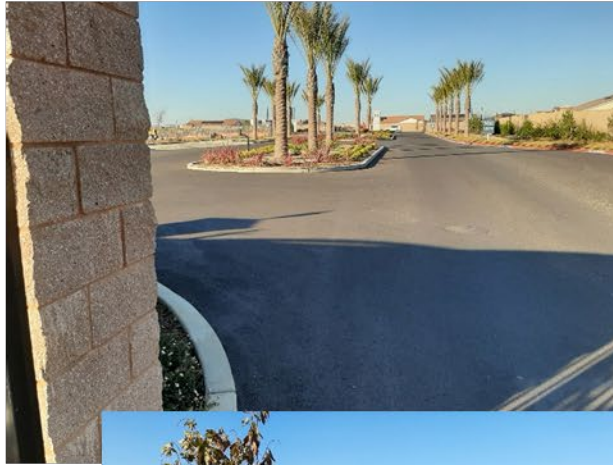
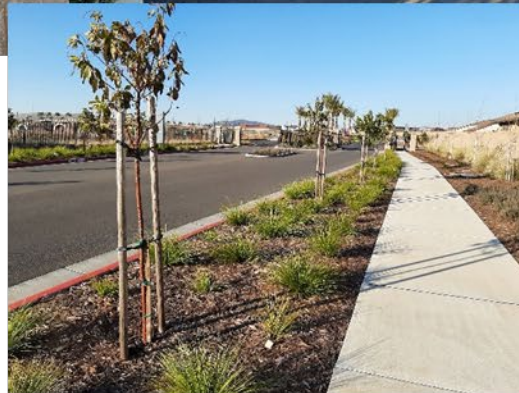
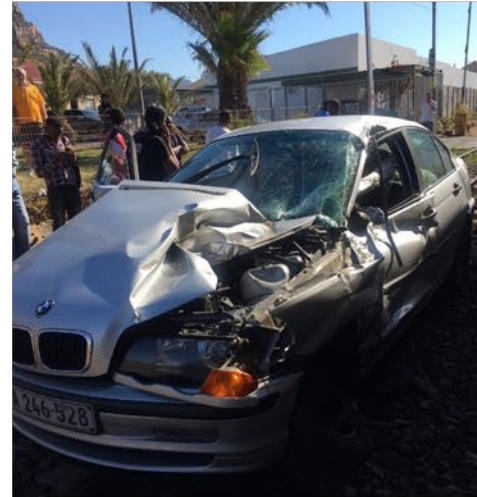
SAFETY CONCERN: PALMDALE NORTH GATE BLIND SPOT

- Parking Lot Exit Not Visible Until Driver is at the Gate
- Cross Traffic from Parking Lot >40 Feet
- Breaking Distance 15 MPH = 44 FT or 25 MPH = 90 FT
- Parking Lot Exit Redesign Required to Mitigate Blind Accidents
